Ref: Property Condition at 9011 Redacted Street, Austin 78703.

At your request we conducted a condition survey at the subject property on 11 & 12 February 2003.

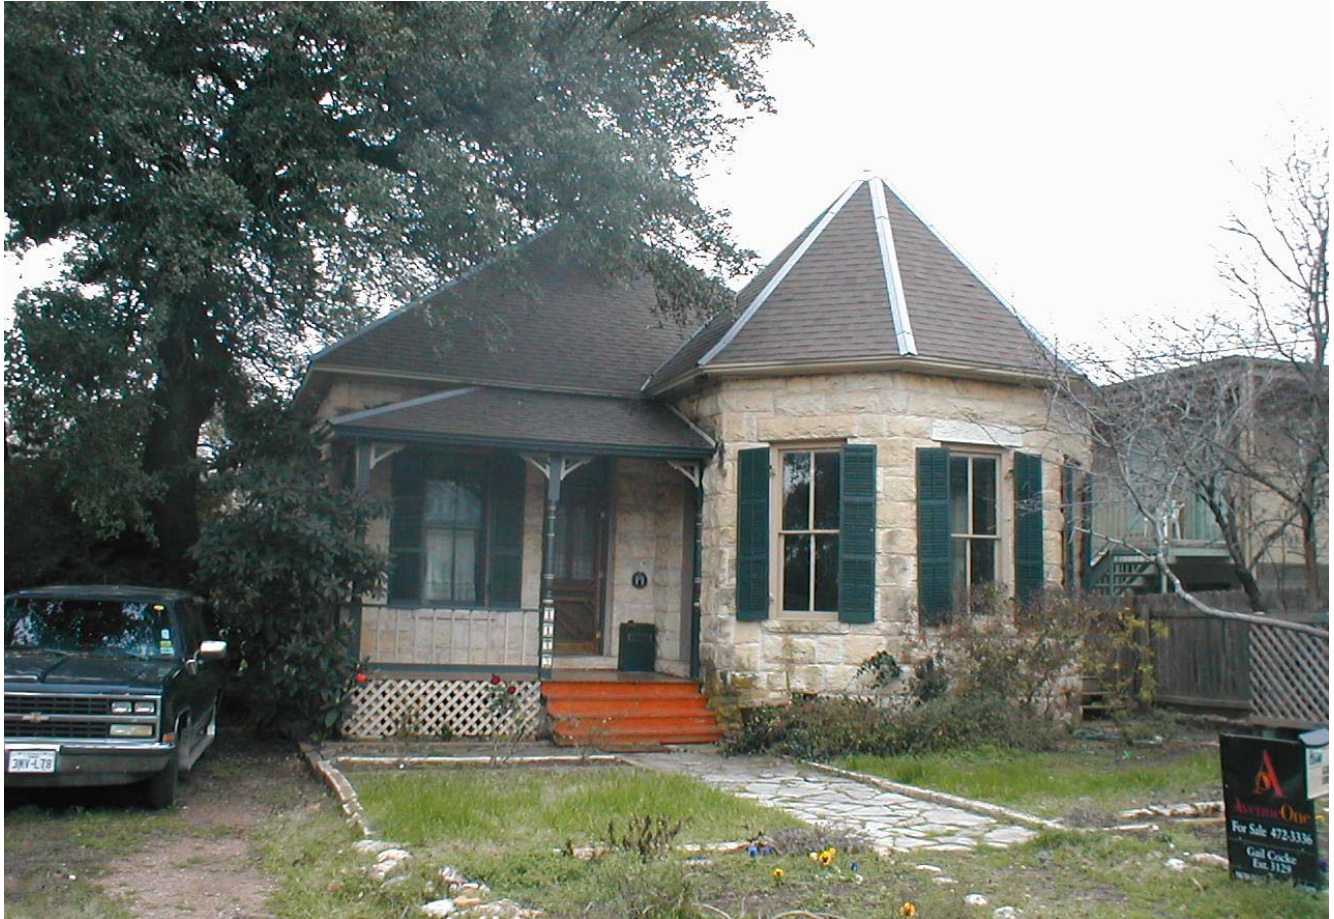
Front Elevation (original house)

There is a small, abutting wooden porch stoop and stair to provide access to the front entries. This has an unventilated shed roof extension over the porch. The front porch is supported on shallow, dry-stacked footings.

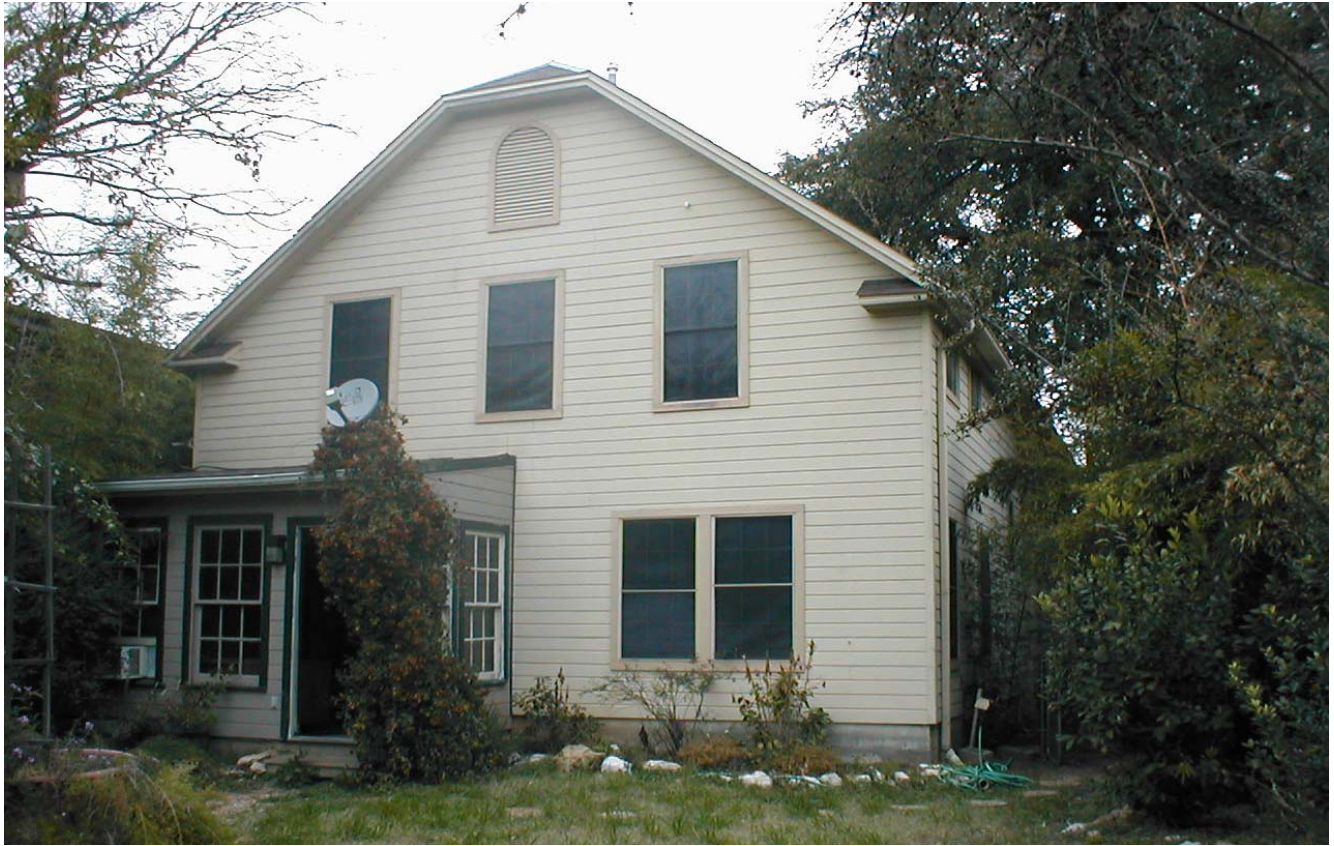
Rear Elevation (addition and converted porch)

At the rear of the addition is a small abutting concrete porch. This appears to have been enclosed, using old wooden sash windows (similar to the main house). The attic structure is an unventilated shed roof.

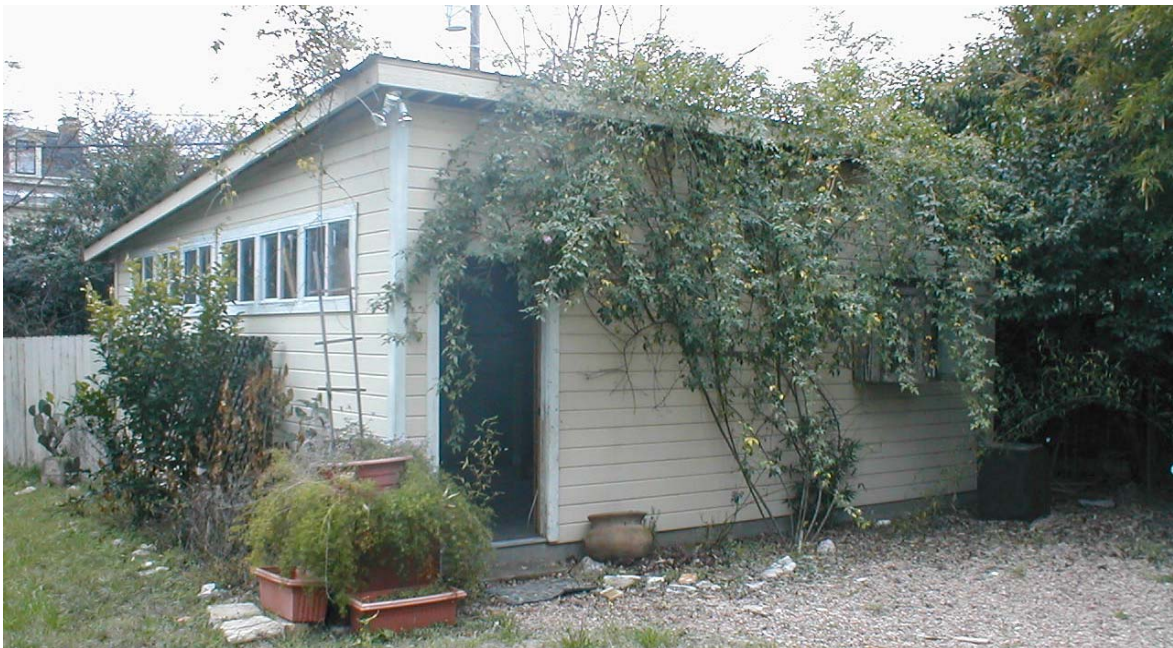
Detached Garage

The garage slab foundation is missing a few conventional details (stem walls and curbstops) but appears to be functioning adequately.

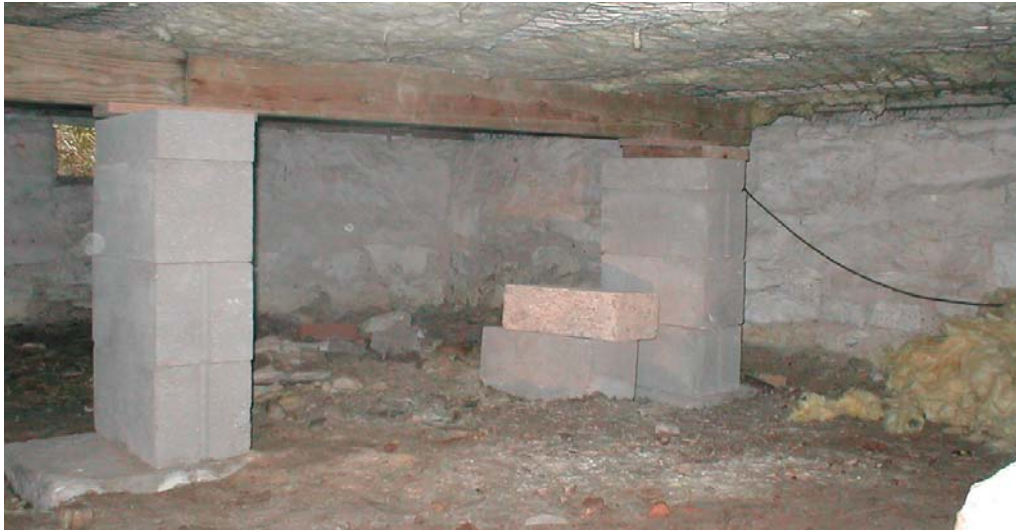
At some point in the last couple of decades shaker beams have been installed near the middle of the joists (one on each side, running front to rear). The beams are appropriate but the post supports are inadequate (dry-stack masonry). These are more subject to soil movement and tend to completely unload themselves over time.

Inadequate Shaker Supports (dry-stack CMU)

In order to obtain optimum performance and to be copasetic with the landmark status of the main house, we recommend that engineered footings and post supports be installed. About twelve supports are needed, but this would also be a good time to also upgrade the front porch footings. Any foundation work should only be performed by qualified contractors, using specifications approved by, and under the supervision of, a licensed engineer (P.E.).<sup>4</sup>

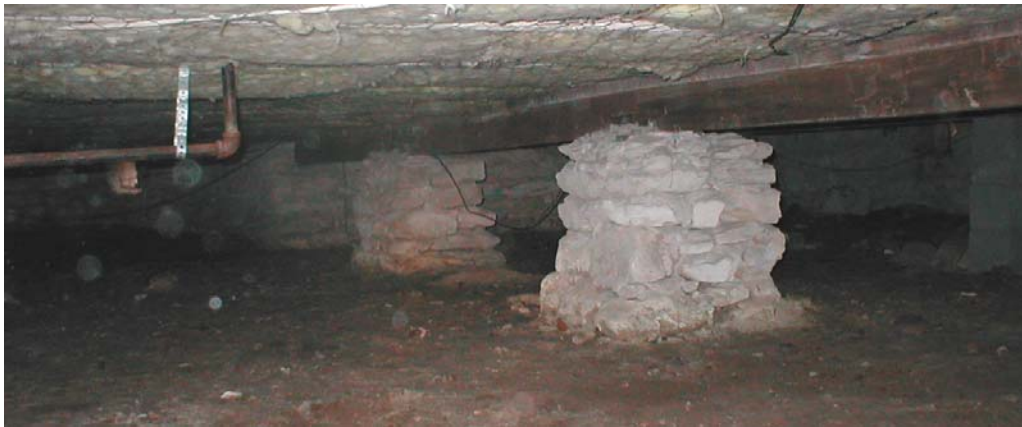
Original (masonry) Post Supports at Main Beam

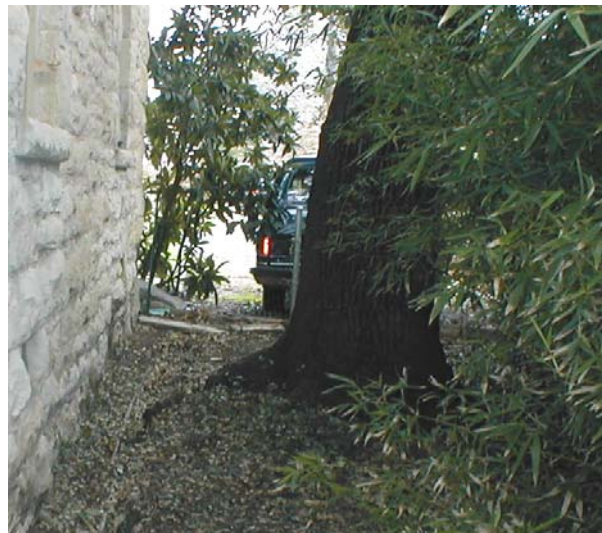
The large live oak at the left is obviously lifting the adjacent footing. This movement has been slight, but will progressively continue. In our opinion a root barrier system is not feasible and the foundation would benefit from removal of this tree at any time. At some future point (when irreparable forms of damage become significant) it will have to be removed. In the event it is retained, the owner should consider root-watering (away from the house) in drought weather.

Very Large Tree in Proximity (left side)

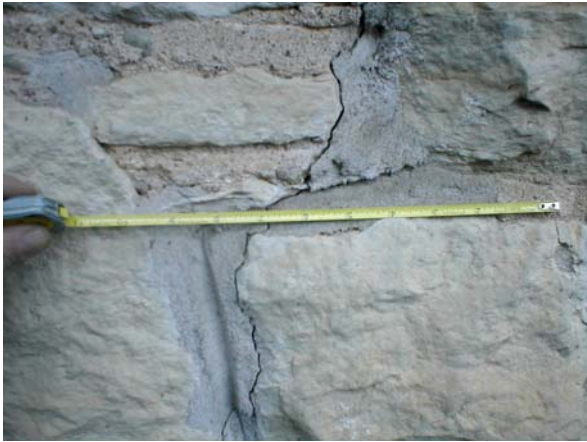
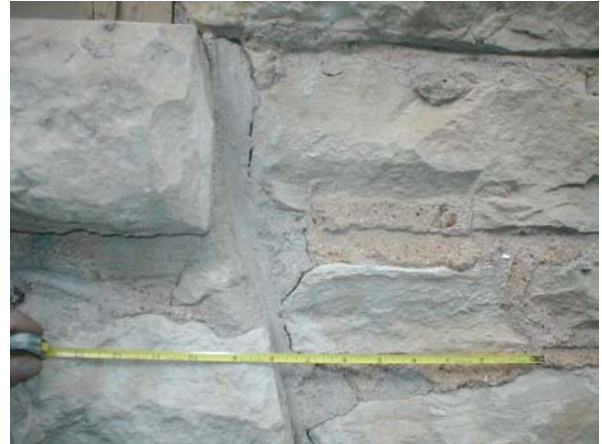
Exterior Flexure Cracks (under windows near the left tree)

- Exterior masonry needs to be re-pointed.
- Exterior masonry exhibits minor flexure cracks (esp. adjacent left tree).
- Exterior masonry sills do not slope away from the windows.

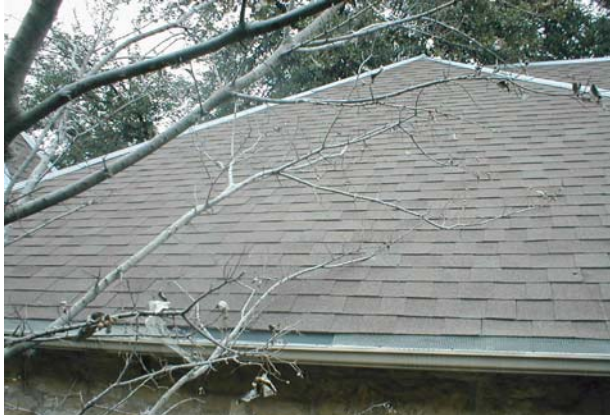
Tree Contact and Abrasion (all around)

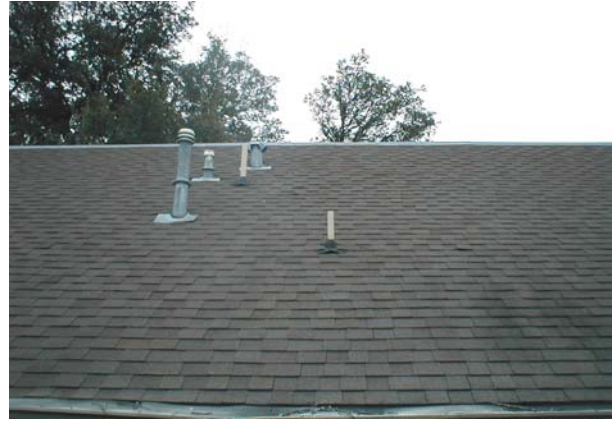
This Area (right rear, facing west) Appears Hail-Damaged

- Extremely heavy debris (esp. left valley under the live oak).
- Right rear slope appears hail-damaged (spalls in shingle aggregate).
- Some fastener withdrawal (fasteners backing out beneath shingle tabs).

Based on observed conditions and apparent age, this roof is an imminent replacement item. Consult a qualified roofer.

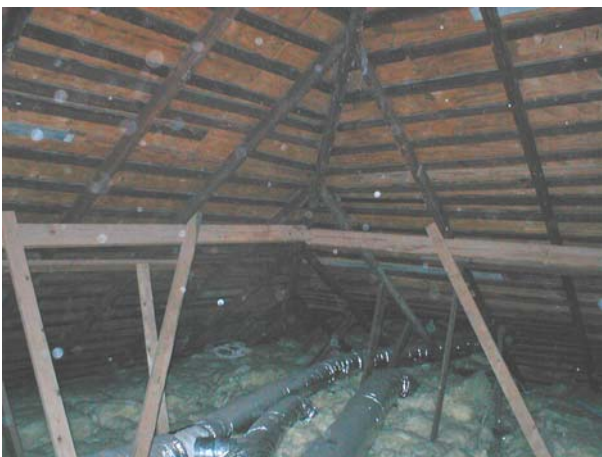
View of Main House Attic (very over-spanned)

- The main house attic is wildly over-spanned (as-built).
- Severe and prolonged leakage is evident beneath the left valley (predictable with so much debris).
- Access decking in the attic is not securely fastened.
- The attic access stair (upper landing) is not insulated or weatherstripped.
- The side attic access door is not well-insulated.
- The access port to the right mechanical enclosure should have a door, not a fastened panel.
- No upper attic ventilation provisions (ridge vents or low-profile hawks).
- The floor materials used at the front bathroom do not appear to be rot-resistive.

The main house framing is so deficient as to be impossible to address by retrofitted bracing, although a single purlin has been added in the past. At this point we do not view it as an immediate hazard, although it will tend to get slowly worse.

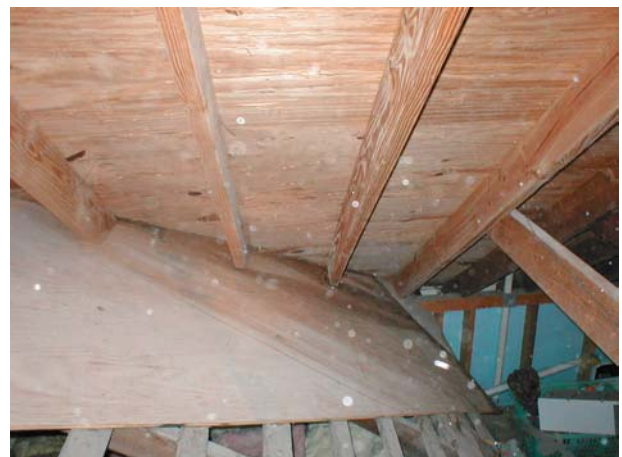
View beneath Left Valley (lots of leakage)

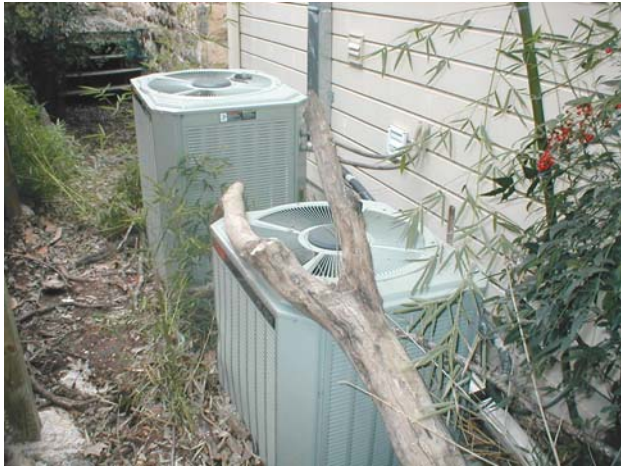
Condenser Units (left side)

- Debris and foliage contact at condenser units.
- The rear (upper zone) condenser has a bent housing, sounds ‘odd’ during operation.
- Cooling at the upper zone was inadequate (-5°F).
- Total system capacity appears inadequate (esp. in view of main house walls).
- Exterior condensate drains (down right wall) need to be extended away from house.
- Partial insulation at condensate piping (both appear to be sweating).
- No P-traps at condensate piping.
- Water stains and past leakage evident around main (lower zone) condensate piping.
- Past leakage or overflow at upper zone condensate piping / Progressive rust in overflow.

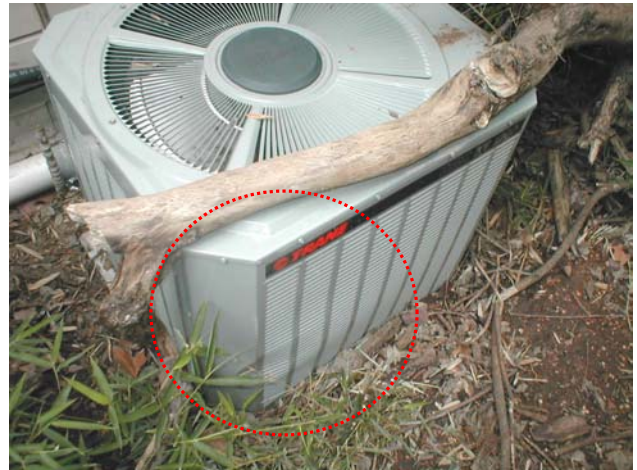
Impact Damage at Rear (upper zone) Condenser

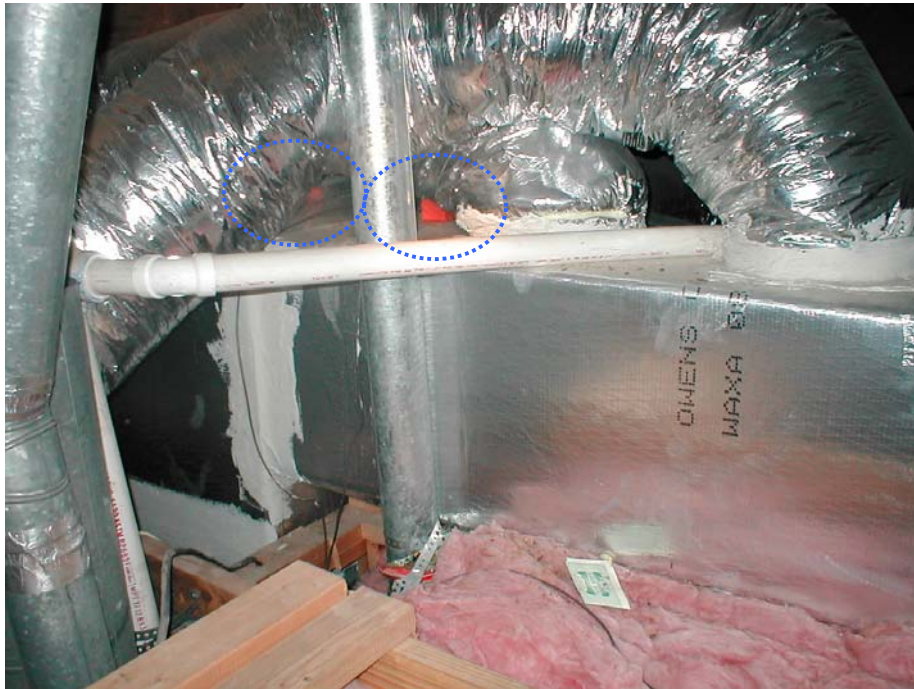
The variable air volume damper system is not a conventional arrangement. In addition to being an undocumented system, the control system design is obviously inadequate. For example, the thermostats will allow both the heating and cooling components to operate simultaneously. The arrangement of the zoning would be problematic even if the heating and cooling were adequately sized. For example, the front thermostat in the main house also controls the lower rear zone. The rear thermostat (controlling demand for the right main house) is located in a kitchen, far from the return air. We recommend a thorough, system-level evaluation and sizing of the heating and cooling systems by a master HVAC technician, in addition to the repairs indicated herein.

Variable Air Volume Dampers (motor actuators are the orange boxes)

- Water heater vent chimney (visible in photo above) is in contact with supply ducts and plenum.
- Improper clothes dryer outlet fitting (plastic louver, should be covered metal flap type).

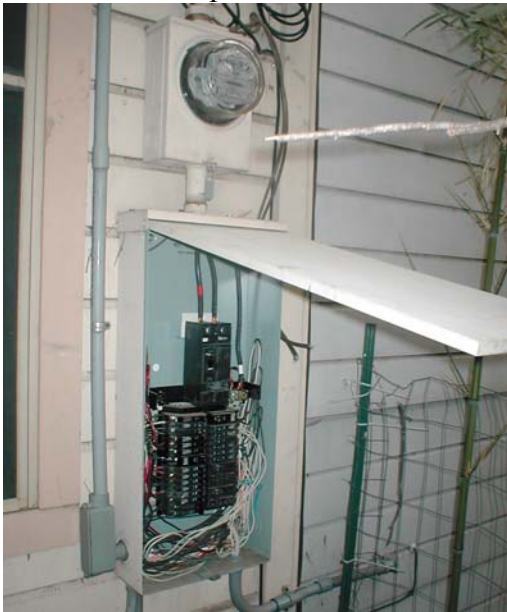
Exterior Service Entrance (right wall)

- Extreme foliage contact with utility drop cabling.
- Foliage (bamboo) is blocking access to the panel and meter.
- Antiquated (3-wire) 220V feeds (major appliances need exterior grounding).

Note this is a minimal service capacity for this size of house. There is no expansion capacity at the main (entrance) panel.
