24 April 2003

Ref: Foundation Condition at 1905 Redacted Avenue, Austin 78704.

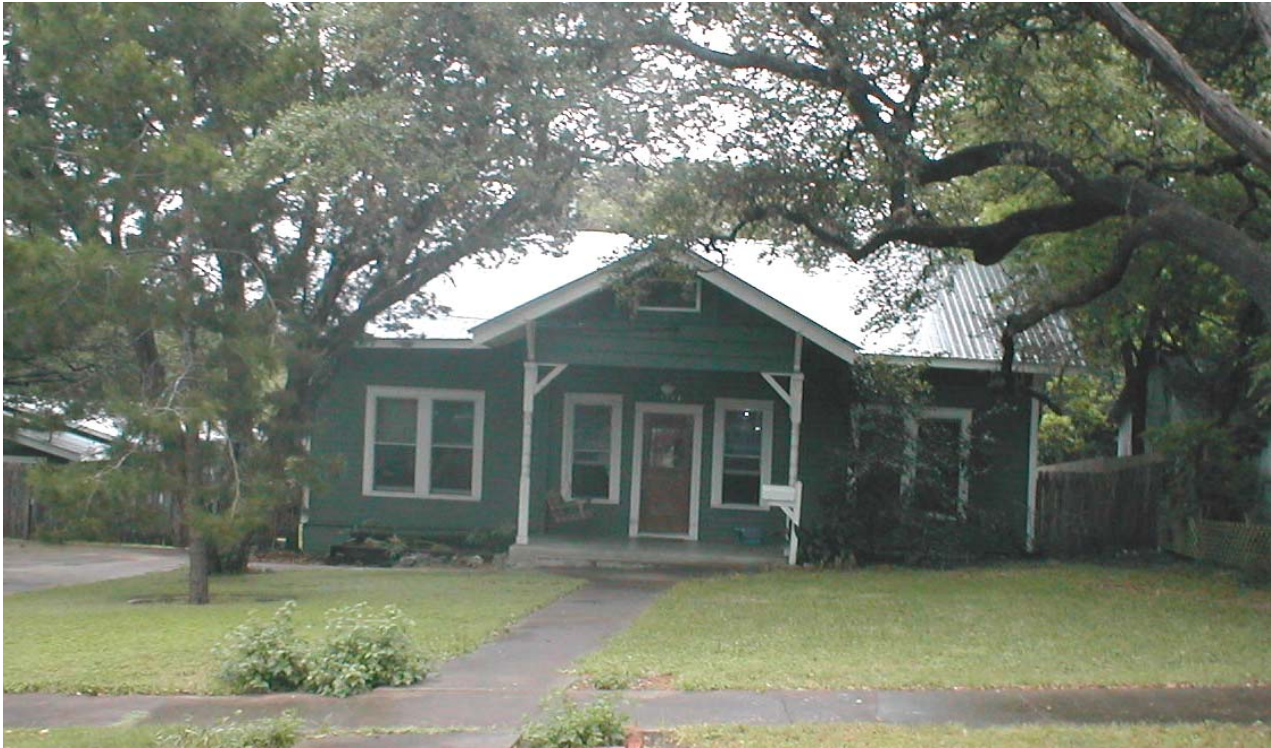
Front Elevation

1. The house rooflines and siding courses are visibly distorted. The exterior walls are at least an inch out-of-plumb.
2. There is inadequate freeboard (clearance between the ground and the wooden floor structure), notably at the right quarter of the house. The corresponding crawlspace areas are inaccessible.

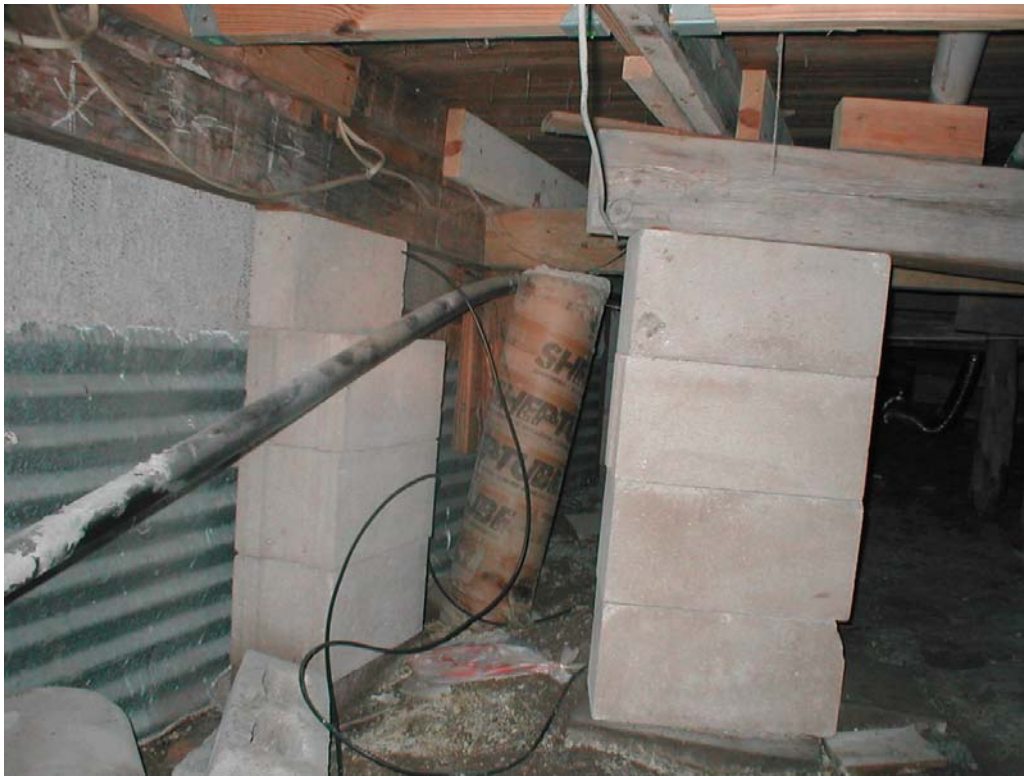
4. The original house post supports are severely deteriorated due to rot (ground contact) and insect damage (subterranean termites).
5. Sonotube repair posts (6-8" in diameter) have been installed adjacent many of the original support locations, but these do not appear to be of substantial construction, although no attempt was made to excavate footings. One of these posts (near the rear of the original house) has completely rotated out from beneath a beam.

6. Dry-stack (CMU block) shoring has also been installed at many locations throughout the crawlspace. These appear to bear on precast cement pads placed on grade.

7. There are also many areas of local cribbing, where beams are shored on dry-stacked blocks or wooden 'stifflegs' have been added.³
8. Some termite damage was evident at the beams, but the (visible) interior surfaces appeared remarkably well-preserved considering the age of the house. They were installed sideways (with the minor dimension vertical) at original construction.

View at Rear Crawlspace (upset sonotube, dry-stack shoring, 'ad-hoc' cribbing, etc.)

1. Installation of appropriate concrete pad footings and post supports (as specified by an engineer).
2. Removal of all existing support structures which are termite-conducive (tree trunks, dry-stacks) or surface bearing (apparently most of everything else).

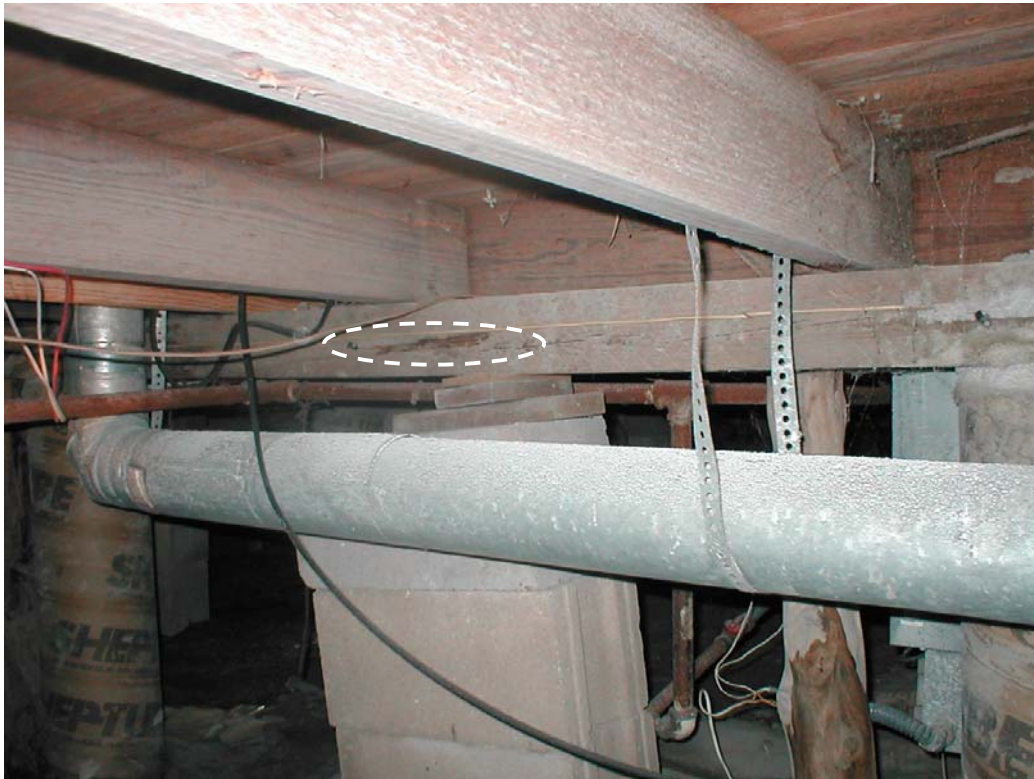
View at Interior Beam (dry-stack shoring, old post support, termite galleries, etc.)

11. Repair of termite-damaged joists (by sistering a pressure-treated joisting).
12. Leveling, as practical (see comments above).
13. Certification of the footing configurations and beam installations by a licensed engineer.

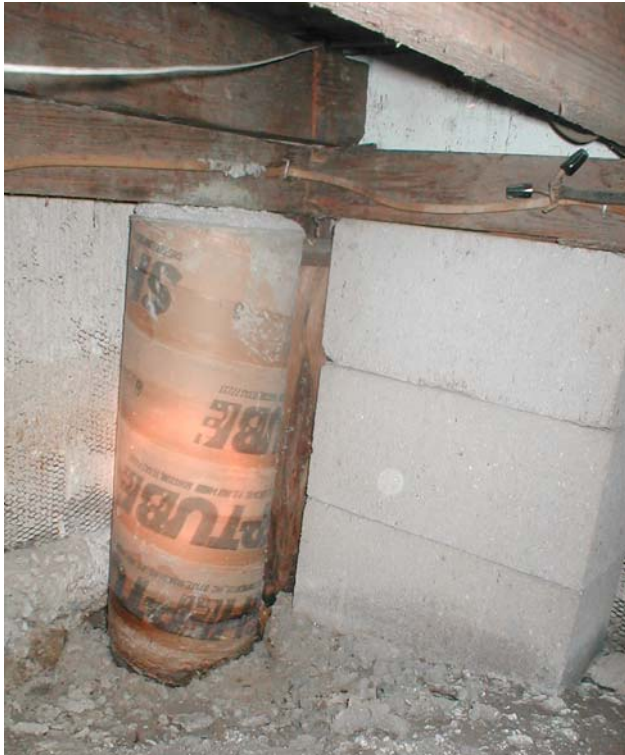
View of Corner Support (left front)

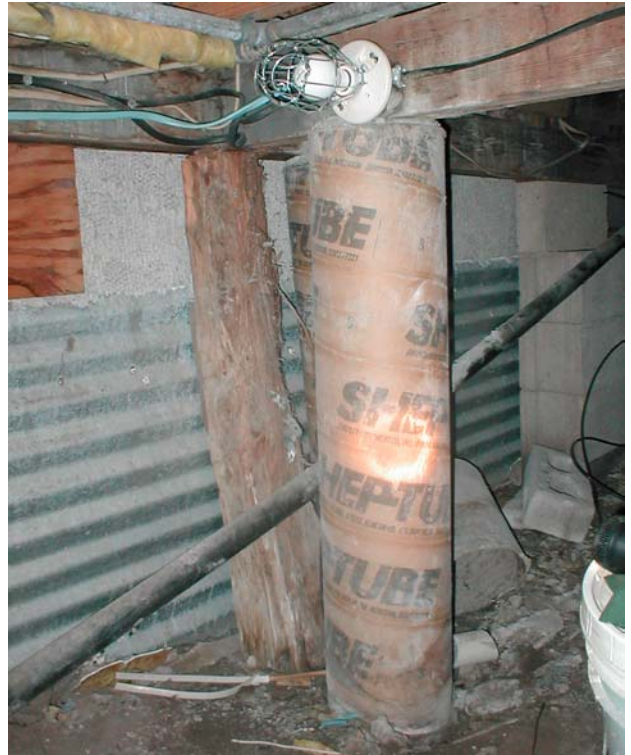
View of Beam Connection Support (rear, left side)

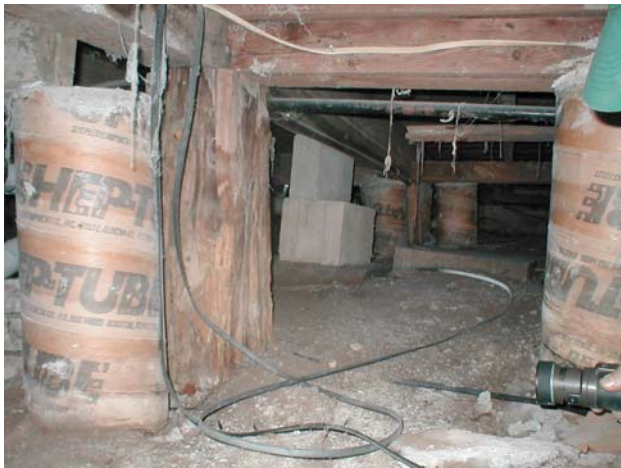
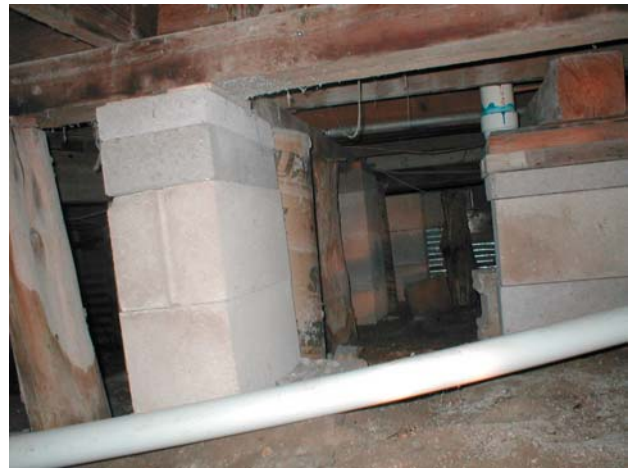
There are a lot of improvised supports in this crawlspace.

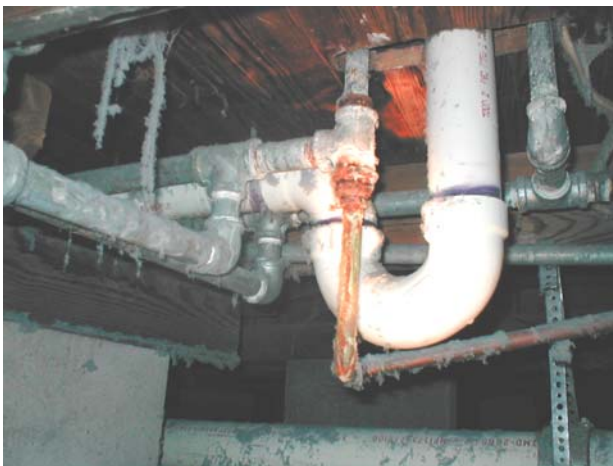
10. Areas of the joisting (2x6, roughly at 24" centers) appear to be overspanned,⁴ most notably at the rear portion of the central living area.
11. Antiquated subgrade (buried) plumbing materials are in service (supply and drains). Some above grade leakage was apparent in the crawlspace.

Less obvious, the buried portions of the supply and drain lines are ferrous materials within the crawlspace. The expected useful life of these materials has been exceeded and they place the foundation at-risk for concealed (subgrade) leakage.

View of Galvanically Incompatible Supply Connection (leaking)

3. Removal or permanent abandonment (in-place) of all wet-service ferrous plumbing materials.
4. Crawlspace excavation sufficient to provide at least 16" clearance beneath the floor structure.

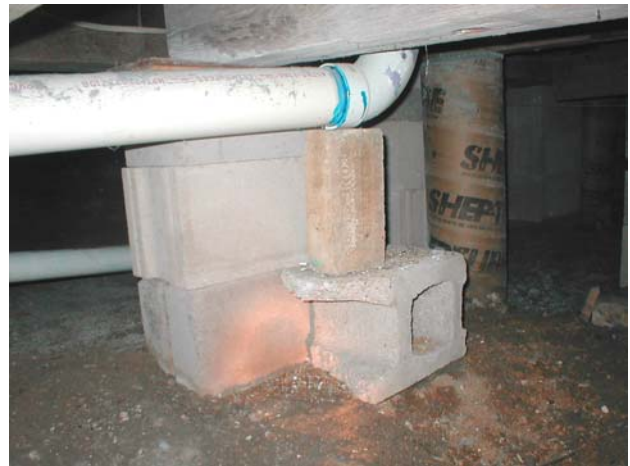
Improvised Piping Support (utility branch)
