Ref: Property Condition at 20100 Redacted Court, City Zip.

At your request we conducted a condition survey at the subject property on 30 October 2003.

FOUNDATION & SITE CONDITIONS (SLAB ON GRADE)

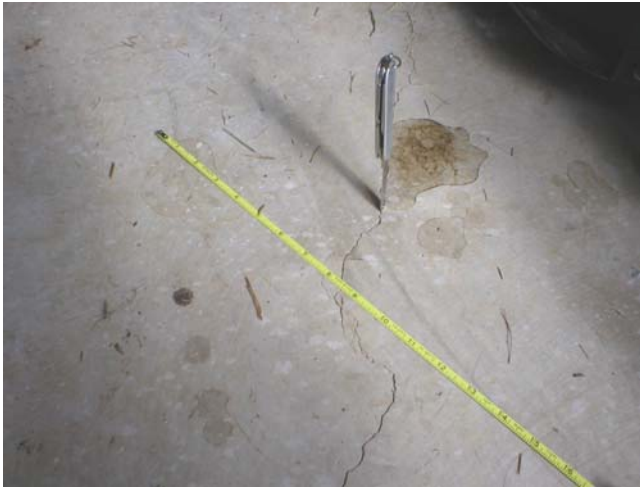
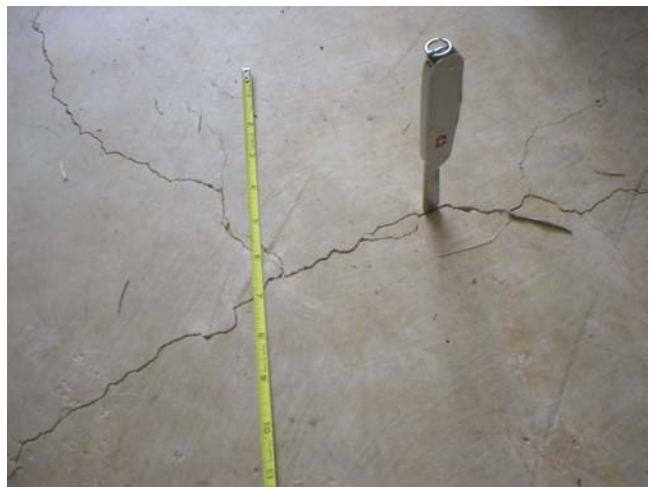
Shrinkage Cracks (at garage floor surface)

As regards structural integrity, the location and morphology of the visible cracks at the upper slab appear typical for those caused by excessive concrete cure shrinkage.⁴ Indicative of poor installation practice, this type of cracking is very common in rural residential slab-on-grade construction. At this point they do not appear severe enough to affect the slab structural function, although they can affect other slab functions, notably flooring. Ceramic tile installed without a crack barrier membrane may reflect cosmetic cracks. Where some slab movement occurs, shrink cracks can also cause mismatch lines in sheet vinyl flooring. Carpet, wood and laminate flooring all perform acceptably on cracked substrates.

In the event any flooring is removed and cracks revealed to be approaching 1/8" across, then these should be evaluated by a licensed Professional Engineer prior to installing the flooring. Further worsening of the visible cracks may eventually require epoxy injection.

We recommend that even tight interior shrinkage cracks be superficially sealed using a suitable polymeric material (e.g., paint the garage floor with polyurethane or epoxy paint). Contact an engineer if the cracks are observed to suddenly splinter or widen.

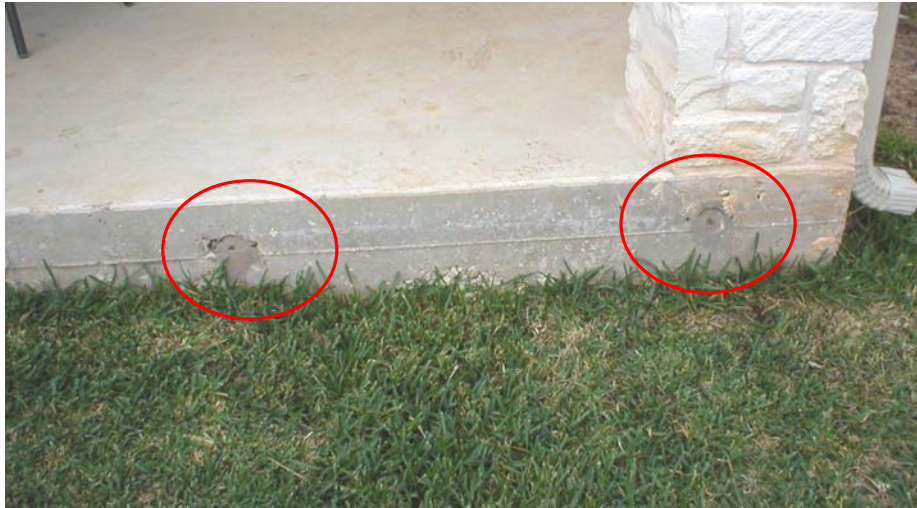
It appears that this is a post-tensioned slab, with the wedge anchors installed along the rear and right sides. These have exposed cable (tendon) ends and should be sealed prior to backfilling against the slab. The subject underpinnings should be excavated, cleaned and pargetted (with Portland-rich plaster) sufficient to imbed the cable ends at least 1/2" before backfilling.

Exposed Tendon Wedges (at rear, others appear to be buried)

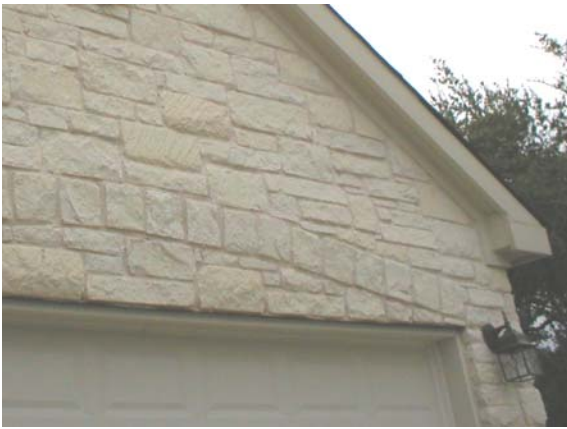
Flexural Cracks above Lintel (esp. at right corner)

- Flexural cracks (about 1/8") evident at right front and left rear corners.
- Flexural and thrust (horizontal) cracks (about 1/8") evident above garage opening.
- Garage lintel is visibly bowed / Lintel member is not painted.
- Window sill masonry is not sloped or well-pargetted / Gaps and cracks around fitments.
- Insulated glass panes at master hall shower appear 'fogged'.
- Tight or binding window sashes at master bedroom (rear elevation).

Although most of the masonry damage is attributable to rotation (subsidence) of the foundation edges, the sagging garage lintel is also contributing at the right front. This is likely to progressively worsen and eventually may result in a hazardous condition (as the masonry is thrust outward away from the gable).

Existing masonry cracks should be repointed with ordinary masonry cement. Any recurrence is evidence of progressive movement and should be re-evaluated.

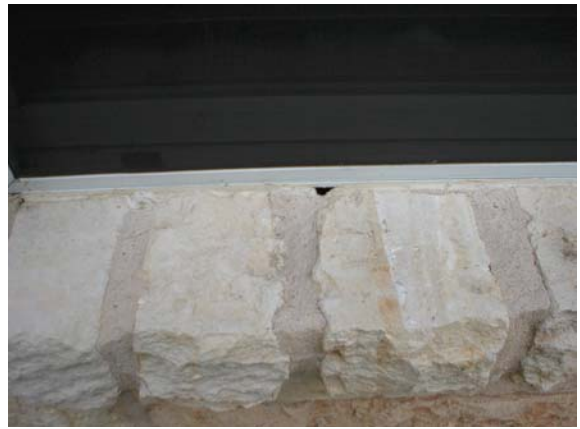
Poorly Detailed Sill Masonry

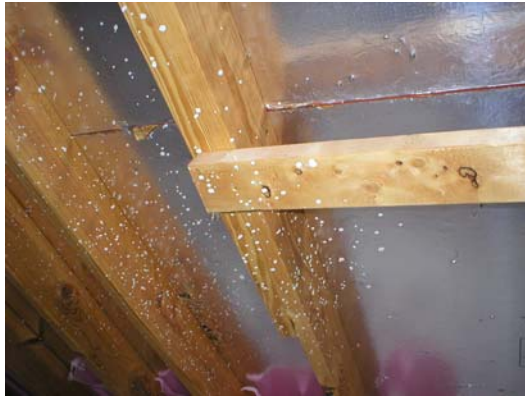
Inadequately Supported Rafter Lap (right slope)

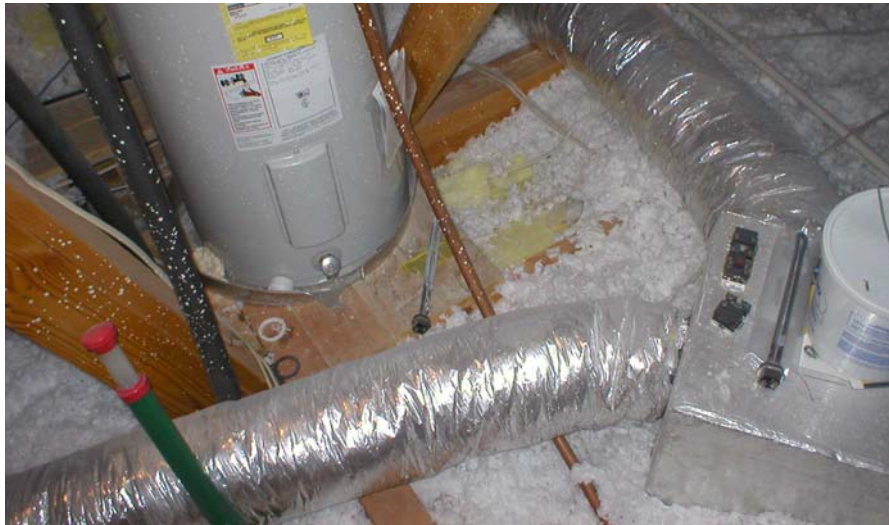
Water Heater (relief valve seized, torn drain pan, risers not blocked, no disconnect, no service decking, etc.)

- Temperature-pressure relief valve would not actuate.
- Improper exterior termination of relief piping (elbow required downward).
- Evidence of past service replacements (elements, thermostats and boiler drain parts).
- The overflow pan is torn (needs replacement) / No drain piping connected.
- No blocking at piping risers.
- No electrical disconnect provision.

Based on the relative age, but number and severity of observed conditions, this is an immediate service or replacement item.

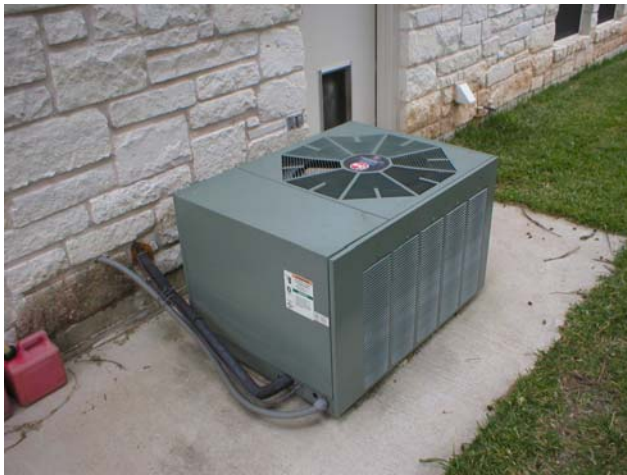
Condenser Unit (right side)

- Condenser unit is beneath an unguttered roof drip edge.
- Exterior condensate drain needs to be extended away from house.
- Interior (attic) condensate piping is not insulated.
- Prolonged condensation or leakage into overflow pan / Progressive rust in pan (see photo).

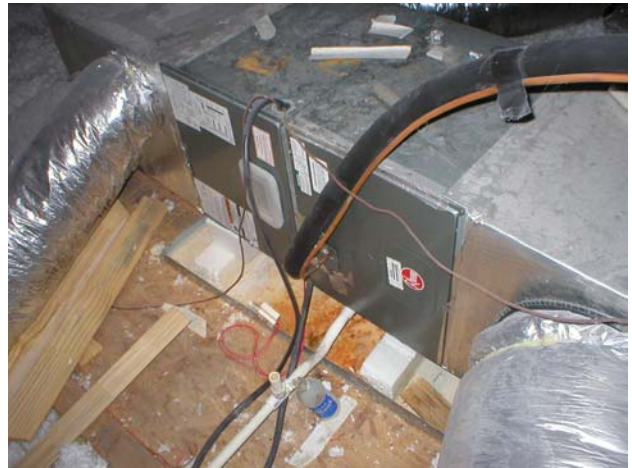
Furnace-Fan-Coil (attic)

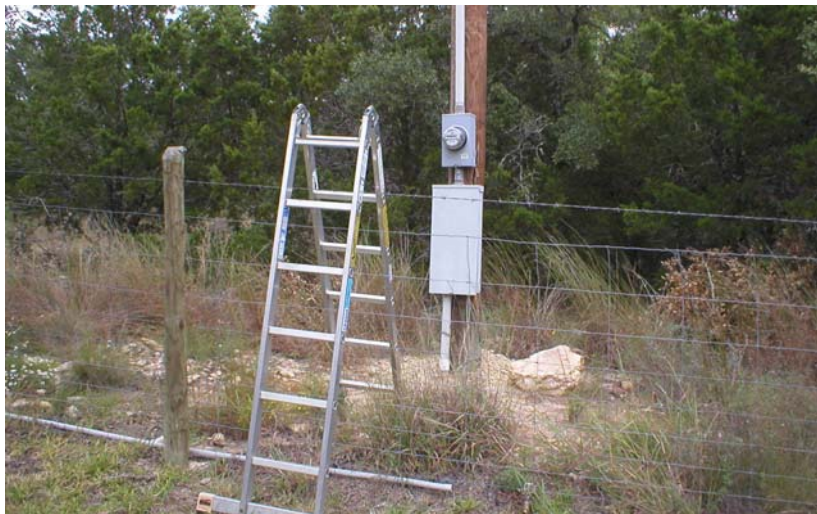
Service Entrance (over livestock fencing?)

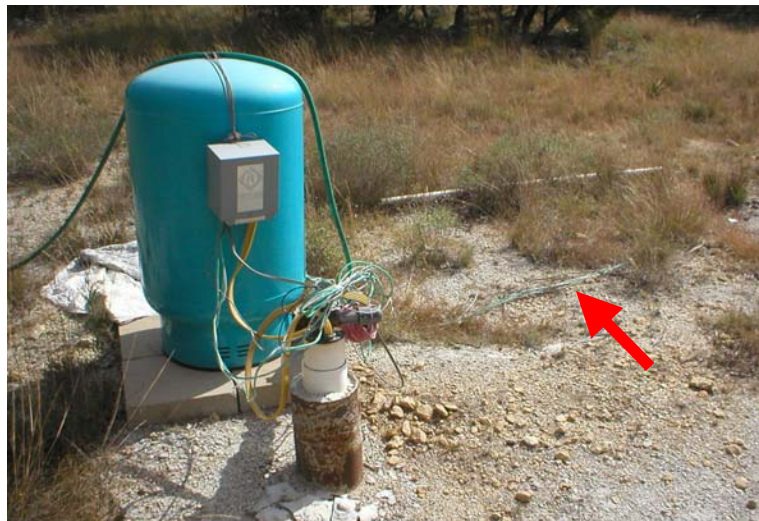
Well Head and Pressure Tank (all that exposed wiring is interior-grade, energized supply cabling)

- Equipment is not housed / Exposed wiring, switch housings and piping.
- Extremely inappropriate supply cabling, routing and strain relief provisions.
- Pressure tank support appears inadequate.
- The pressure gauge is not functional.

This is obviously not a workmanlike installation. It's time to build a wellhouse.
