Ref: Structural Conditions at 6038 Redacted Drive, Austin 78730.

PURPOSE AND SCOPE

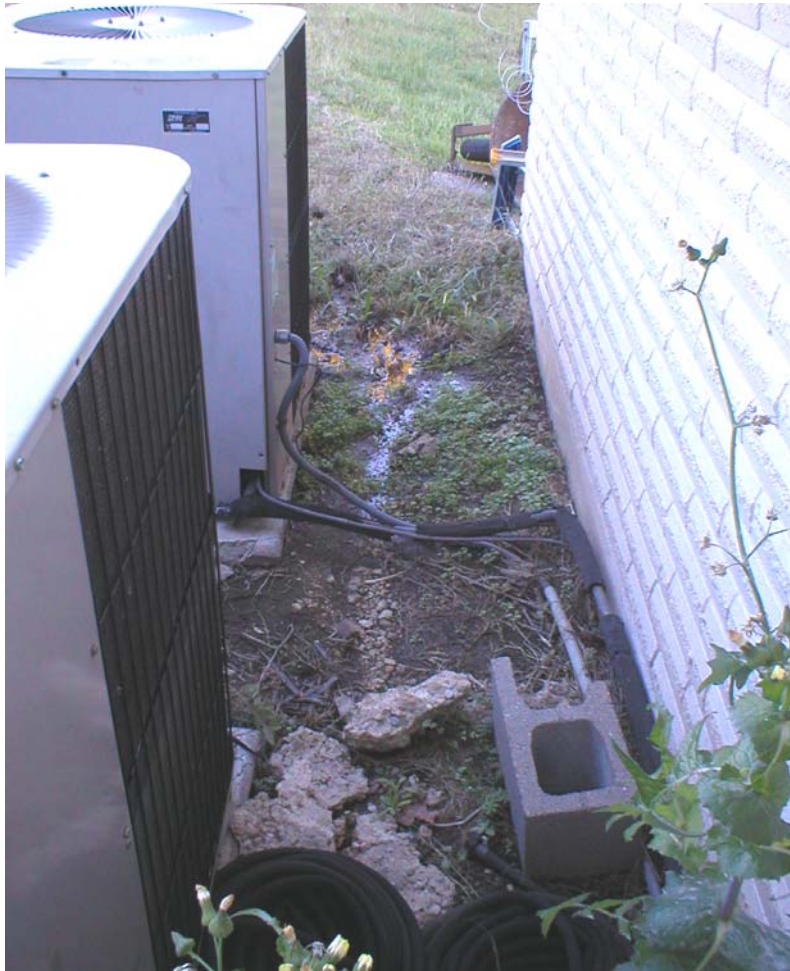
2. There is saturated soil and standing water all around the left-facing wall of the rear (behind the house, to the right of the driveway, near the air-conditioning condensers). The source of this water was not determined.

Standing Water Upslope of Foundation (rear, to right of driveway)

No apparent source was located. The tenant has not been operating the air conditioner, there is no hose bibb nearby, septic equipment is 12-15' away and slightly lower, etc. Client reports anecdotally that a condition inspector noted the water meter turning even with all the interior stop valves off.

The source of the ponding water at the rear should be immediately identified and eliminated. At this point a licensed master plumber should be retained to functionally test the supply plumbing and isolate any suspected branch leaks.⁷ Absent any identified plumbing leaks, then evaluation of the septic disposal system should be undertaken. Absent any septic problems, then site-specific geotechnical evaluation (exploratory boring for groundwater) might be indicated.

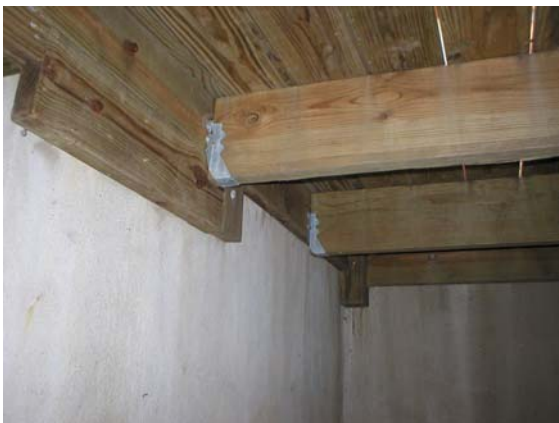
8. At the rear decking (installed around the raised pool edge) the installed ledgers are missing washers at some of the anchor studs. Skewed joist connections do not have hangers. Some of the metal hangers are under-sized and installed on undersized ledgers (hanging from a couple of nails).

Under-Sized Joist Hangers, Inadequate Lags (beneath deck)

The deck ledgers and hangers can be addressed by any competent carpenter. The pool leakage should be referred to a specialist. In my opinion this leakage is unlikely to foreseeably affect the house (at least at the current rate).

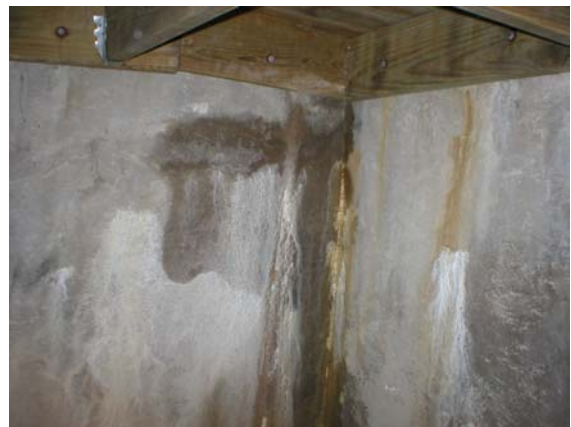
9. There appears to be some seepage through the pool enclosure, visible beneath the deck on the house side (near the spa).

Seepage at Pool Enclosure (beneath deck, near spa)

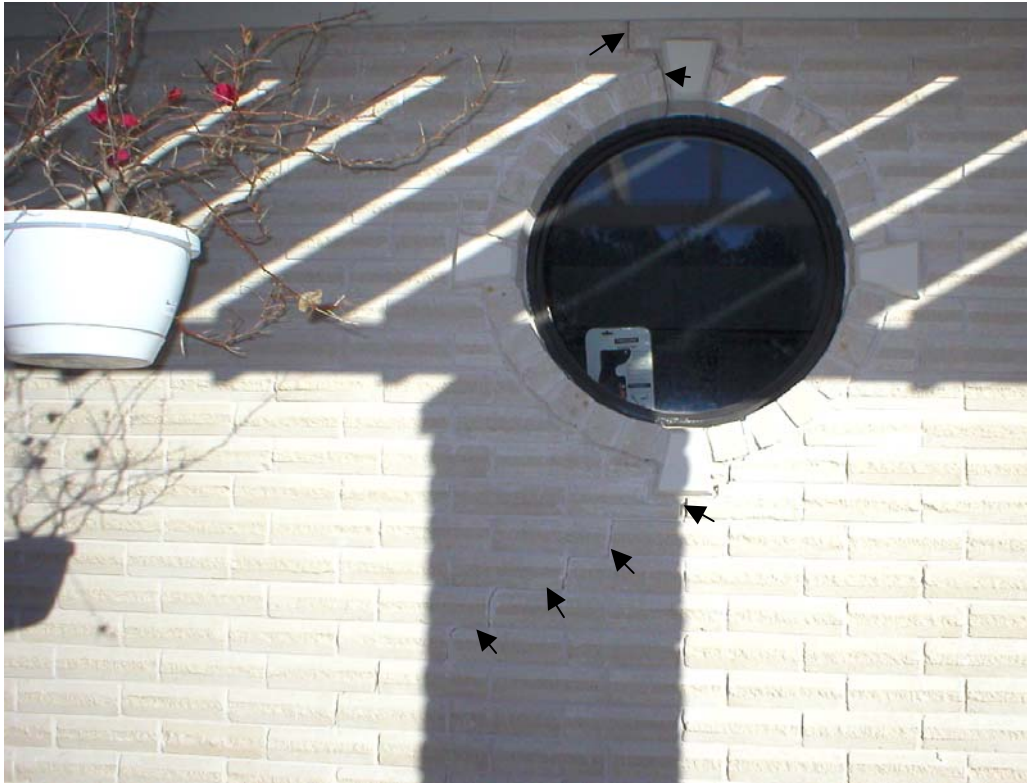
3. There are minor flexural cracks around the house in the masonry veneer. The most visible is at the front elevation, near a round window to the left of the entry. This is stair-stepped diagonally toward the window, open about 1/8" around the window casing. Other minor cracks were noted at the garage door opening, around post corbels at the balconies and adjacent an upper balcony at the right side.

Flexural Crack at Front Elevation (left of entry)

This crack appears to have a flexural component (causing diagonal propagation) but the absence of contraction joints and proximity to the window suggest that material shrinkage has also contributed.

Cracks in the masonry veneer may be cosmetically re-pointed as desired. Some sealing (caulking) of the decking penetration into the right columns should be attempted, but the cracks at the lower columns may continue to worsen with time.

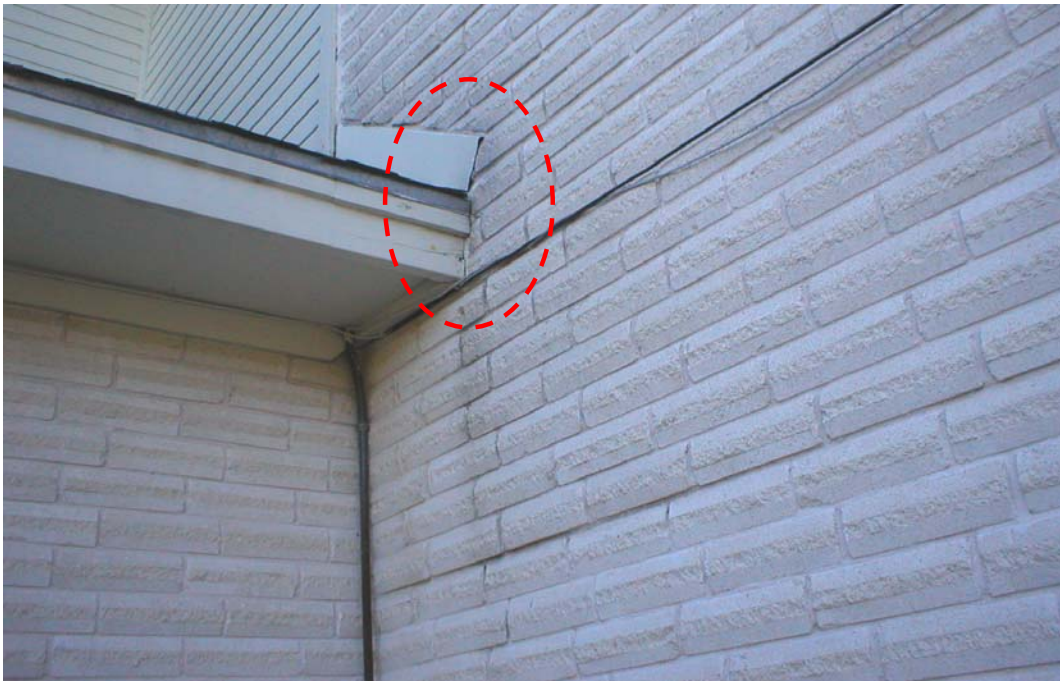
5. The roof headwalls roll flashings do not extend to drip edges and there are no kick-outs, leading to cosmetic masonry stains and progressive rot in the visible roof-edge fascia. Some of these areas have been caulked or partially re-flashed.

Example of Inadequate Roll Flashing with No Kick-Out (one of several)

The roll flashings should be addressed as part of a routine re-shingling, which is due in a couple of years. Any progressive fascia rot should be addressed before re-painting the trim.

The owner should plan a roofing replacement in the next couple of years, to include flashing details. Some coordination should be attempted between the repainting (addressing fascia rot), re-flashing and gutter installation, to avoid redundant work. Ideally the order would be paint, flashing, roofing, then guttering.

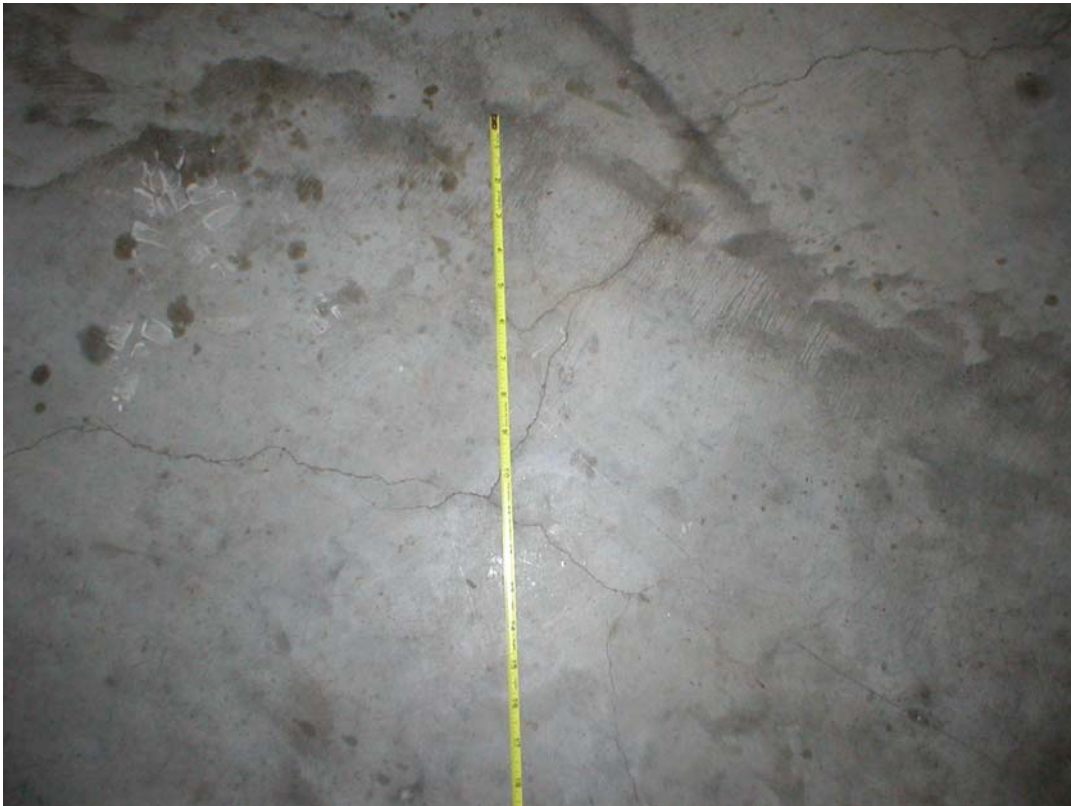
1. Shrinkage cracks are evident at the exposed slab surface in the garage and at the exterior porches. The majority of these are tight (1/16" or less across), but slightly more open in the transverse direction (i.e., front to rear).

Shrinkage Cracks at Garage Floor

- The cracks at the exposed garage surface probably initiated due to concrete shrinkage. However, slight movement (probably imposed by subsidence at the right) appears to be progressively widening some of these cracks. At this point they are not structurally significant.
- These types of cracks are also likely to be present at interior areas. Even when such cracks are not structurally significant (i.e., tight), they can affect other slab functions, notably flooring. Ceramic tile installed without a crack barrier membrane may reflect cosmetic cracks and this appears to be the case within the house. Carpet, wood and laminate flooring all perform acceptably on cracked substrates, but this can be termite conducive.

These cracks are not affecting structural performance. They should be superficially sealed in traffic areas.

In the event any flooring is removed and slab cracks revealed to be open more than 1/16", then these should be evaluated by a licensed Professional Engineer prior to installing the flooring. We recommend that even tight interior shrinkage cracks on traffic surfaces be superficially sealed using a suitable polymeric material (e.g., paint the garage floor with tractable polyurethane or epoxy paint).
