Subject: Property Condition at [property address].

At your request we conducted a condition survey at the subject property on [date].

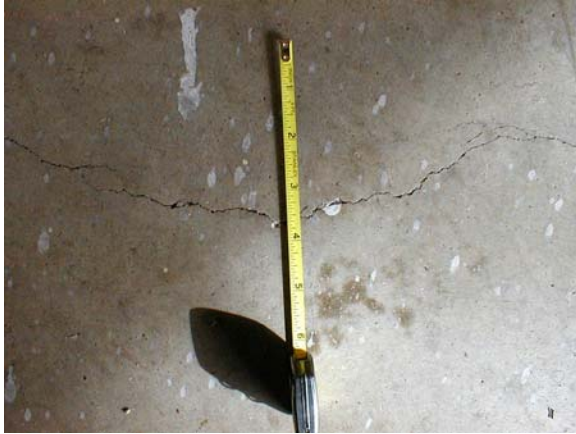
- Upper slab (at garage and tiled foyer) shows advanced shrink cracking.
- Foundation exhibits about ½” convex settlement (typical for age and area)
- Progressive perimeter erosion (unguttered eaves) at sides and rear.
- Perimeter ponding at sides and rear.

Slab Shrinkage Crack (at garage)

The location and morphology of the cracks at the exposed garage surface and at the interior tile locations (foyer) are consistent with excessive cure shrinkage. These cracks tend to form inside transverse sections. As a general rule, 90% of shrinkage cracking typically occurs during the first two years after initial construction. The cracks we observed do not appear structurally significant and, absent other defects, should not worsen. Although the structural function of the slab is not affected, shrink cracks represent a minor breach of the environmental barrier (potentially allowing ingress of moisture, vapor, radon, insects, etc.). For this reason the owner may wish to superficially seal exposed cracks with an appropriate material (e.g., exterior-grade polyurethane caulk).

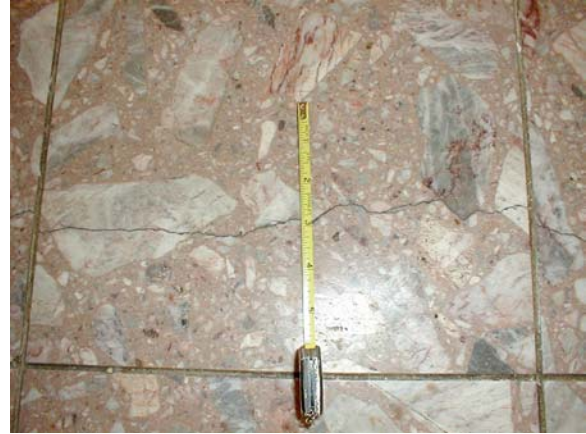
Reflected Shrinkage Crack (at foyer)

Shrink cracks also degrade the slab function as a tile substrate. Tile damage due to reflected shrink cracks can be substantially reduced by installing a crack barrier membrane prior to laying tile. Carpet and wood flooring are usually not affected by shrink cracks. However, sheet vinyl flooring typically does not perform well on cracked substrates.

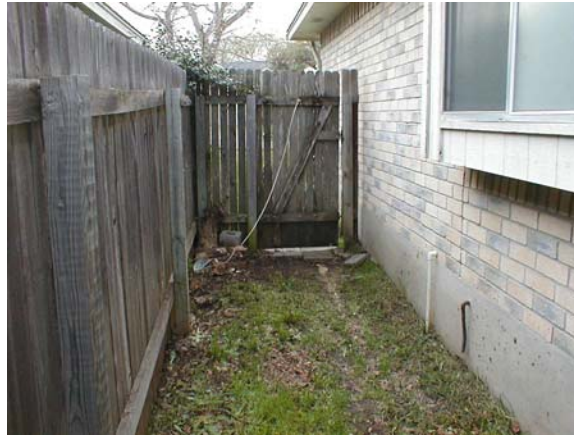
There is evidence of slight differential settlement around the perimeter. Although typical in a shallow slab on expansive soils, this settlement is largely attributable to poor site conditions. Transient saturation can temporarily reduce the bearing capacity of natural soils and/or fill materials. In its current condition this settlement appears very slight and does not affect the structural integrity of the foundation. However, we recommend improvements to perimeter drainage to reduce perimeter settlement. This would include:

View of Right Yard (progressive erosion beneath eave)

1. Guttering all drip edges. Conveying downspouts at least 24” away from the house.
2. Backfilling eroded areas to provide positive slope away from the house (sides and rear).
3. Sealing perimeter slip joints (abutting slabs) with suitable polymeric or asphaltic material.
4. Extending the air conditioning condensate drain away from the house.
5. Repair of leaking sprinkler supply piping / Do not operate sprinkler in wet weather.

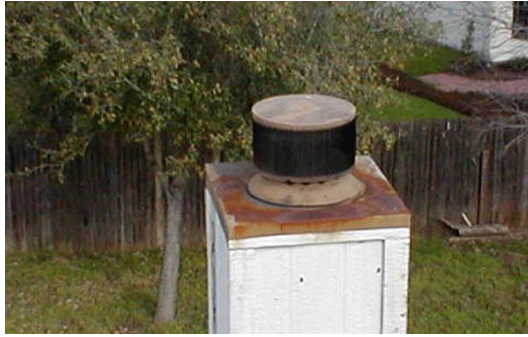
View of Chimney Crown (from roof)

- Log lighter nozzle not supported.
- Advanced rust at metal chimney crown.

We recommend gas logs for this type of installation.

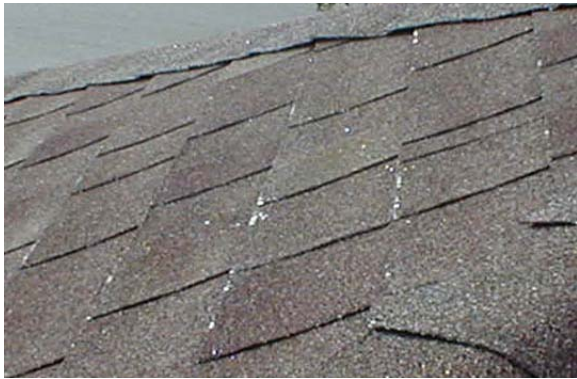
Detail of Surface (tabs abraded)

- Not recent roofing / Brittle / Aggregate roll-off / Spalls and abrasion (ice and hail damage).
- Loose roll flashing (left front gable) / No valley flashings / Roof jacks (vinyl) are weathered.
- Missing shingle at left hip ridge cap.
- Progressive rot at fascia and trim (esp. front and right).

The expected useful life of the roofing has been consumed. It is an imminent replacement item.

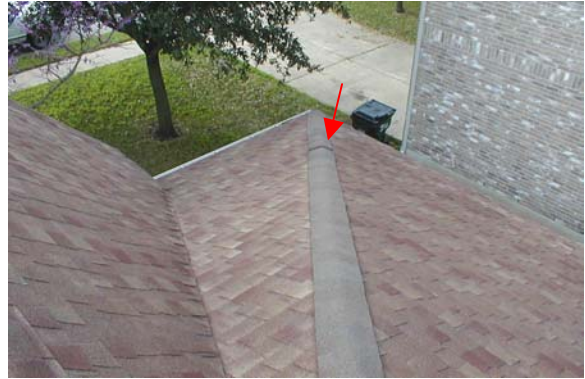
Missing Ridge Tab (front left hip)

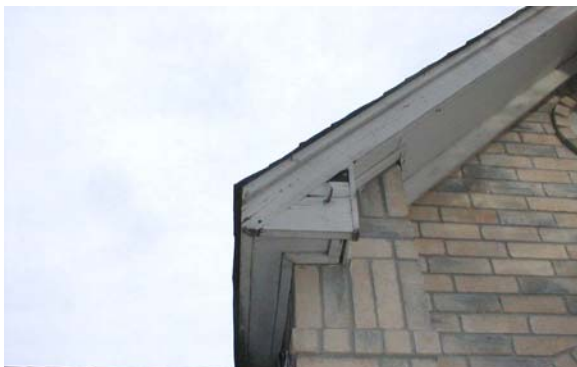
Deteriorated Fascia & Eave Trim (front)

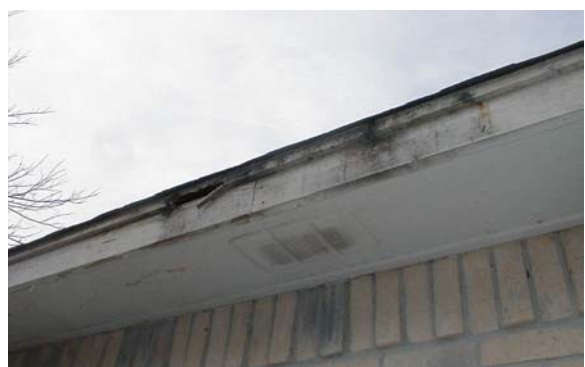
Deteriorated Fascia and Drip Mold (right)

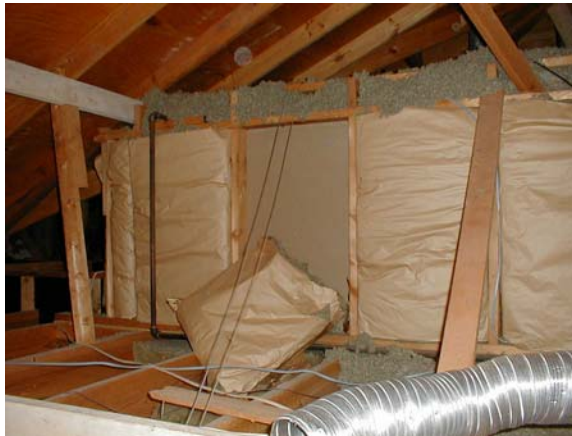
Fallen Batting at Attic (raised ceiling walls)

- No upper attic ventilation (holes cut in wrong location, covered with shingles at rear slope).
- No draftstopping (open ceiling) at furnace mechanical closet.
- Loose and fallen insulation batting at attic headwalls.
- Marginal ceiling insulation (12” recommended).

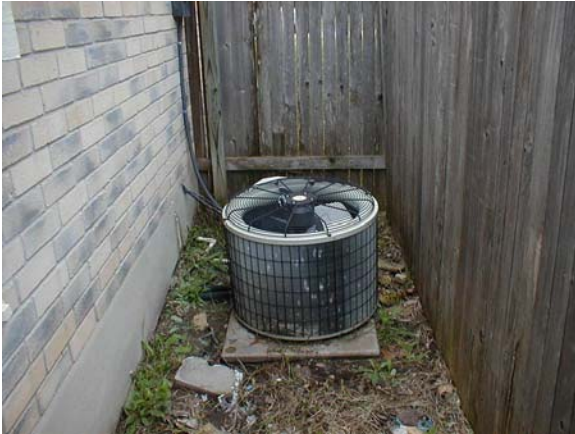
Exterior Cooling Equipment (left side)

- Not recent equipment / Advanced weathering at condenser unit / Coil damage.
- Exposed (repair wiring) to condenser fan / Some vapor line insulation is missing.
- Condensate drain needs to be extended to an area that does not pond next to house.

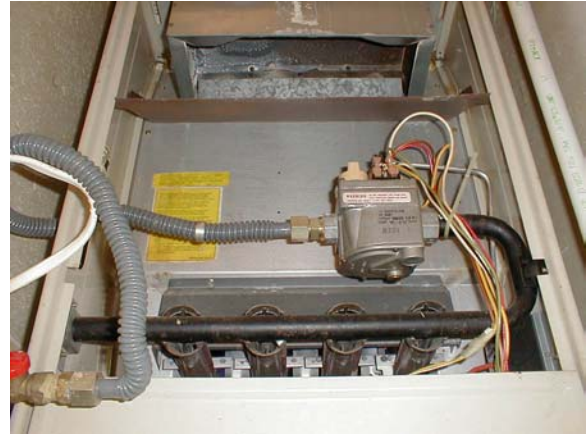
Furnace-Fan-Coil (at foyer mechanical closet)

- Not recent equipment / Rust at heat exchanger / Keep serviced and install CO detector.
- Inadequate combustion air provisions (no attic ducting, see enclosure).

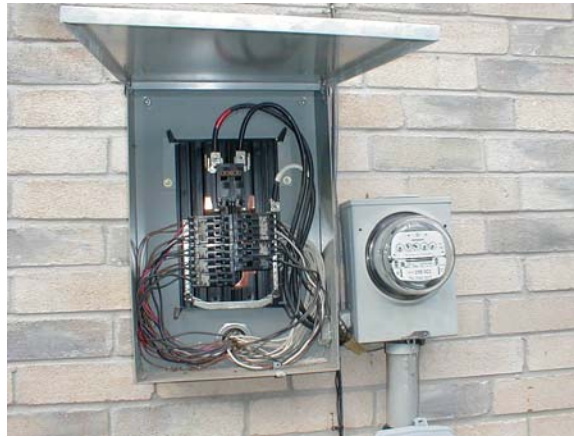
Exterior Service Entrance and Distribution Panel (right side)

- Marginal labeling at branches (minor).

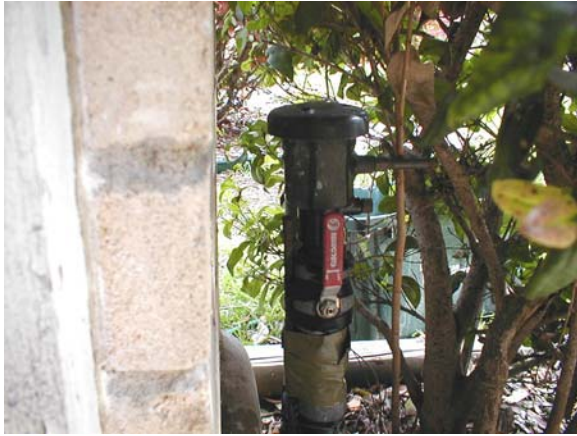
- Zones poorly labeled at controller / Yard (zone) valves not located.
- Anti-siphon valve (adjacent right garage) leaked continuously.
- Extremely low flow at zone 1 (apparent debris in system).
- Low flow at zone 2 / Zone 5 operated continuously (would not shut off).
- Zone 6 did not operate.
- Overspray (hitting house) at zone 4 and zone 7 (front planters, causing interior damage).

Sprinkler Anti-Siphon Valve (leaking)

We recommend further evaluation and repair of the sprinkler system by a qualified specialist.

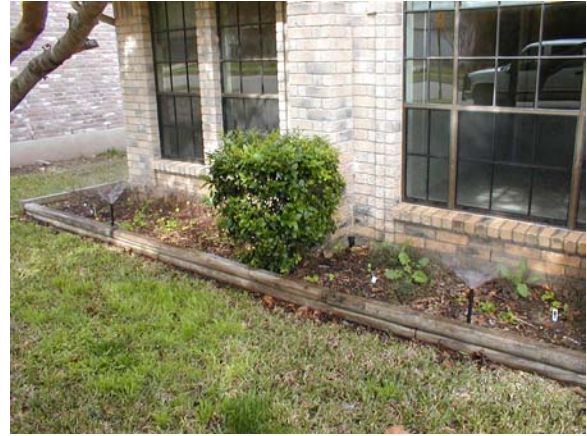
Front Planter Spray Heads (extreme overspray)

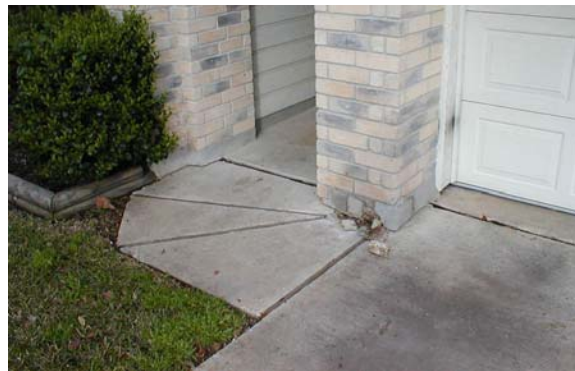
Front Masonry Veneer over Flatwork Slip Joints

No evidence of wood-destroying insect activity was noted. However, the masonry veneer is placed over the front flatwork slip joint, forming a concealed path for termite foraging. This is a recognized termite conducive condition and we recommend preventive treatment and/or mechanical correction of this condition. Other noted conducive conditions (foliage, fascia rot, etc.) are within the purview of owner maintenance.
