Ref: Property Condition at 9011 Redacted Street, Austin 78703.

At your request we conducted a condition survey at the subject property on 11 & 12 February 2003.

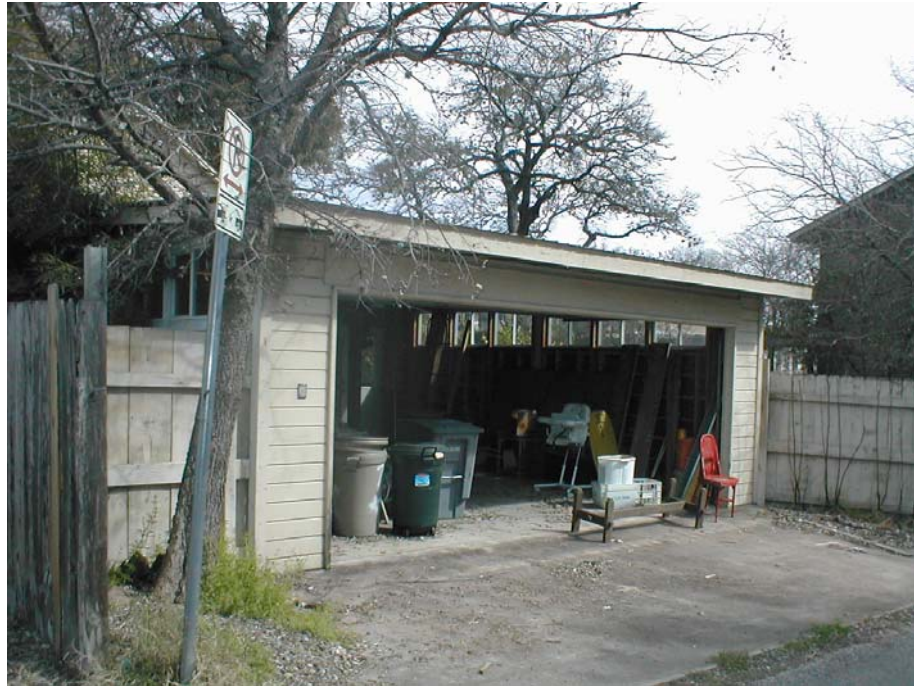
- Extreme foliage contact all around.
- Exterior siding and trim need paint (same as addition).
- Side and rear (alley) walls have no shear bracing / Front wall bracing is inadequate.
- The rafters have no barges or bridging (open to exterior, rafters free to rotate).
- Window screens are not mounted.

The garage slab foundation is missing a few conventional details (stem walls and curbstops) but appears to be functioning adequately.
