Ref: Property Condition at 20100 Redacted Court, City Zip.

At your request we conducted a condition survey at the subject property on 30 October 2003.

FOUNDATION & SITE CONDITIONS (SLAB ON GRADE)

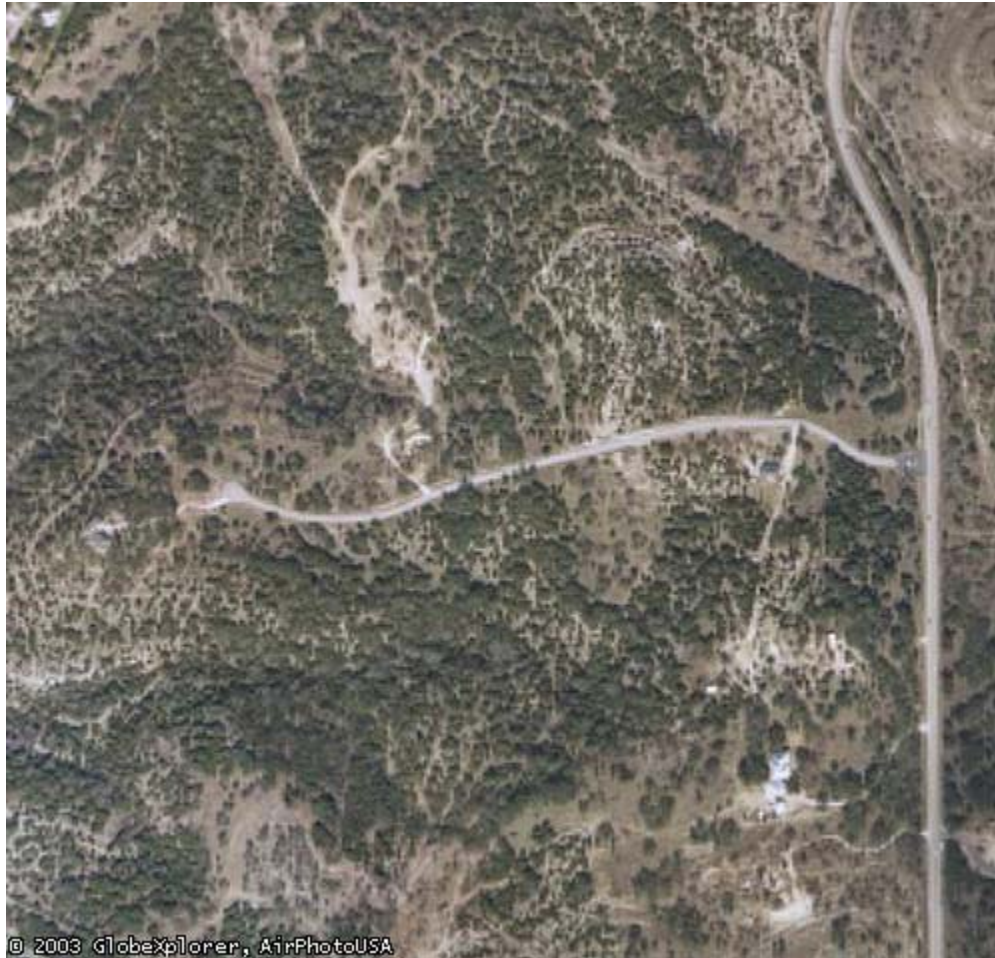
Visible perimeter soils range from gravelly, stony caliche, shallow silts (natural soils) and reddish loams (backfill materials). Ground cover was in variable condition (good at the right and rear, bare and eroded at the left).
